Manhole Inspection Summary

Manhole # S39KK_028MH

Location Address: **1750 AISQUITH ST**

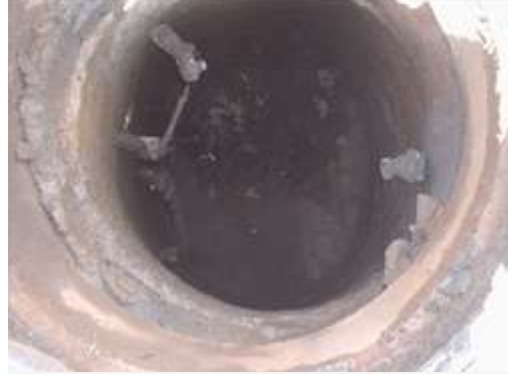
Top View

Corroded and missing steps. Channel debris.

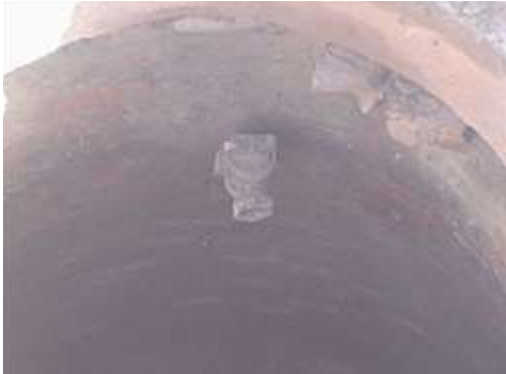
Water Valve

Corbel and Barrel infiltration.

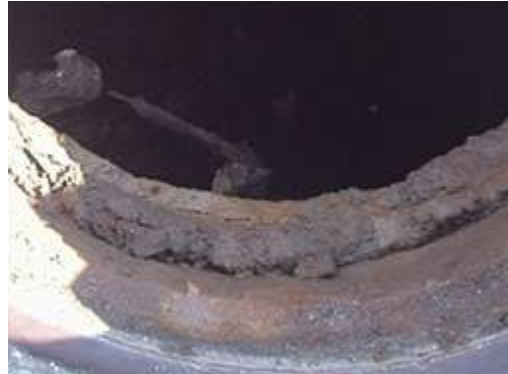
Defect

Frame leaks. Frame offset. Adjustment deterioration and infiltration.

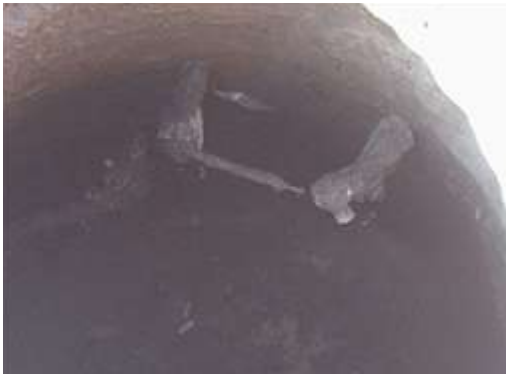
Defect

Barrel infiltration. Corroded and missing steps.

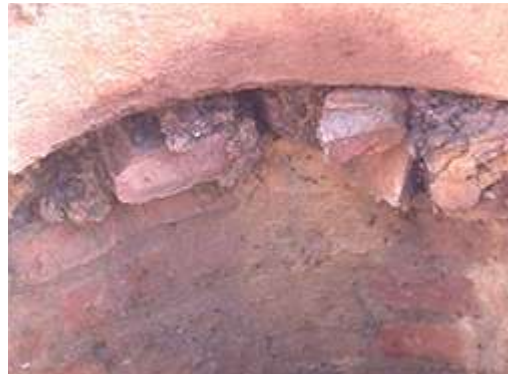
Defect

Frame leaks. Adjustment deterioration, loose brick and infiltration.

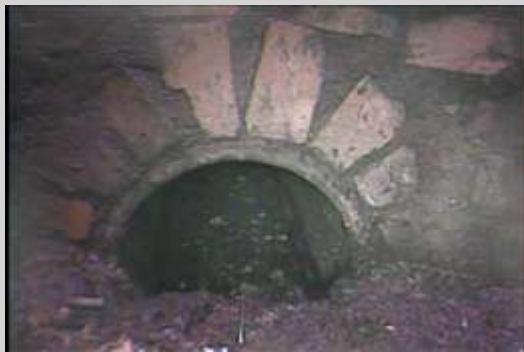
8 in. Circular Gravity Sewer
Pipe Out @ 12 O'Clock

Deposits: ☐ None ☒ **Mud** ☐ Sludge ☒ **Debris** ☐ Grease

Silt Depth: **2** (in.) Deposits Extent: **Light**
